Infiltration Reduction Plan Lower Nailbourne

August 2021
Version 3.1

from
**Southern
Water**

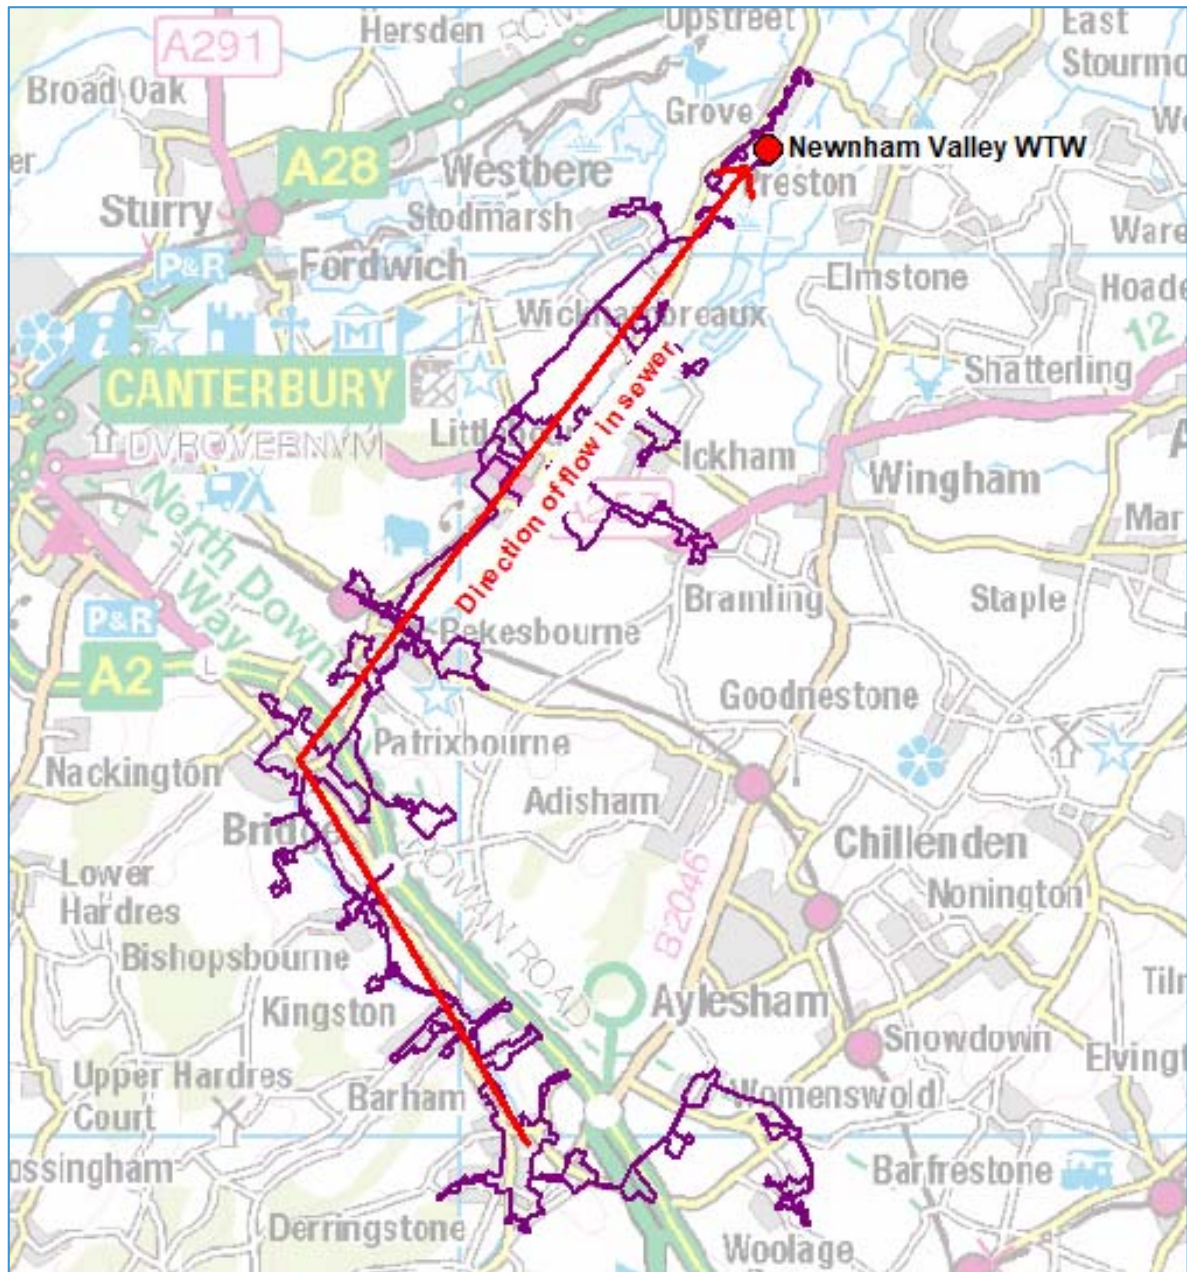
Figure 1 - Representation of the sewerage system for the Nailbourne in the Newnham Valley WTW catchment

Figure 1 shows flows to Newnham Valley WTW. In this area flows from Barham gravitate northwards through Kingston, Bishopsbourne, and Bridge. The resultant flow gravitates in a north-easterly direction to School Lane WPS in Bekesbourne from where it is pumped to Newnham Valley Works.

Flows from Littlebourne gravitate to Nargate St WPS from where it is pumped to join the gravity flow downstream of the rising main from School Lane WPS. The resultant flow gravitates in a north-easterly direction to Newnham Valley WTW in Preston. Sewage flows from adjacent sub-catchments to the north and east are also received by Newnham Valley WTW.

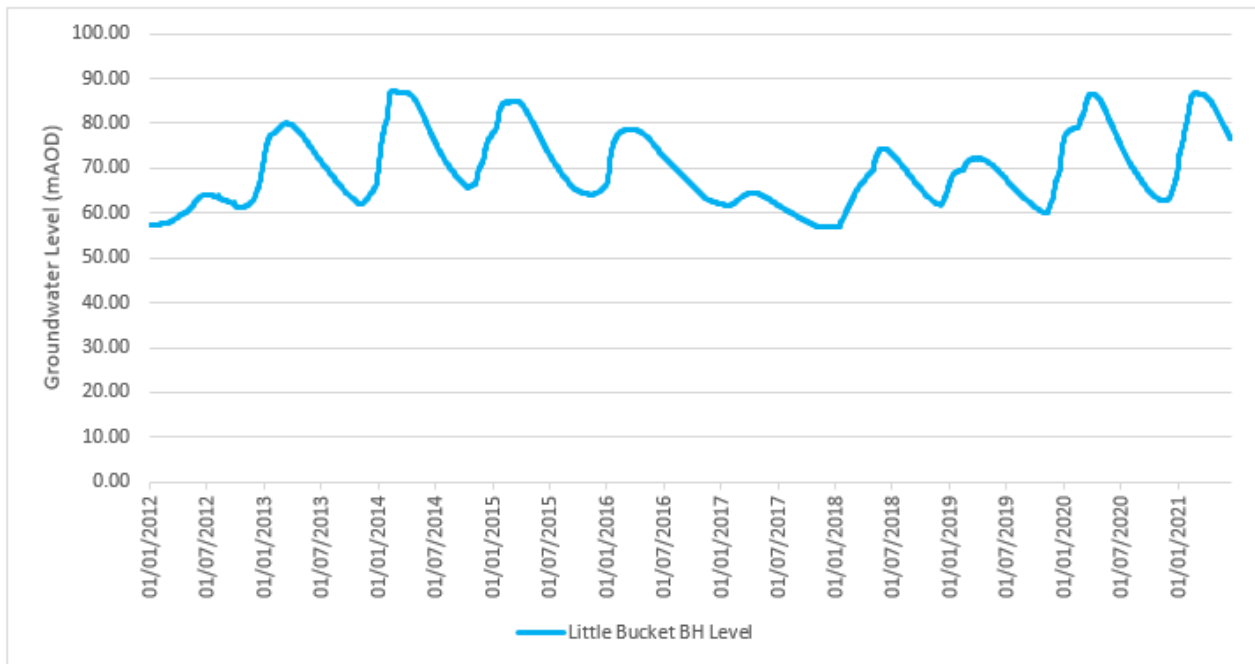
Figure 4.1 - Groundwater levels from 2012 to 2021

Figure 4.1 shows the groundwater levels recorded at Little Bucket since 2012. Pumping was required in 2012/13 and 2013/14, and tankering in 2014/15 with some repair activities in 2013/14 and 2014/15. Tankering was used for one day in February 2016, but only as a precautionary measure. From February 2016 to end 2019 the groundwater levels did not rise above circa 75m AOD and no tankering was required. However in both winter/spring 2020 and 2021 the groundwater levels recorded at Little Bucket peaked at around 87mAOD and tankering was required. The peaks recorded in these two groundwater seasons are the highest cumulative recordings in the time that infiltration has been tracked to this level of detail.

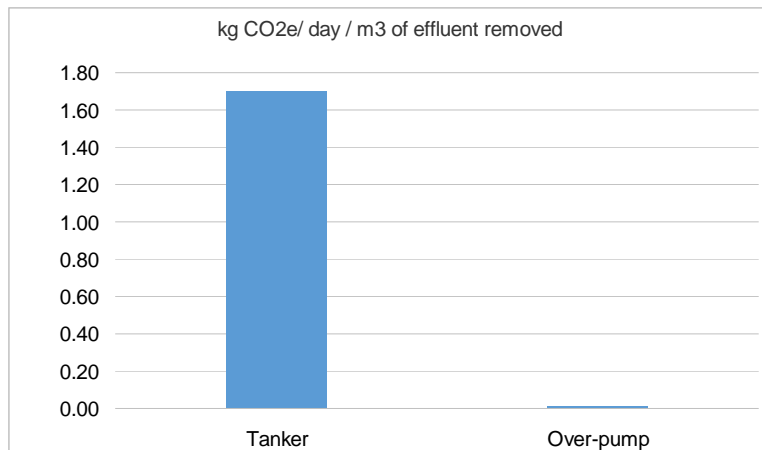
Figure 4.2 – Carbon Footprint figures for Tankers and Over-pumps per m³ of effluent removed.

The graph in Figure 4.2 shows the estimated carbon emission per m³ of dilute effluent removed by tanker and by pump. In this example, data has been used for tankers and the 6 inch pump at Bishopsbourne in 2014. Data for the tankers is taken as an average of the 2,000 gallon and 3,000 gallon tankers used.

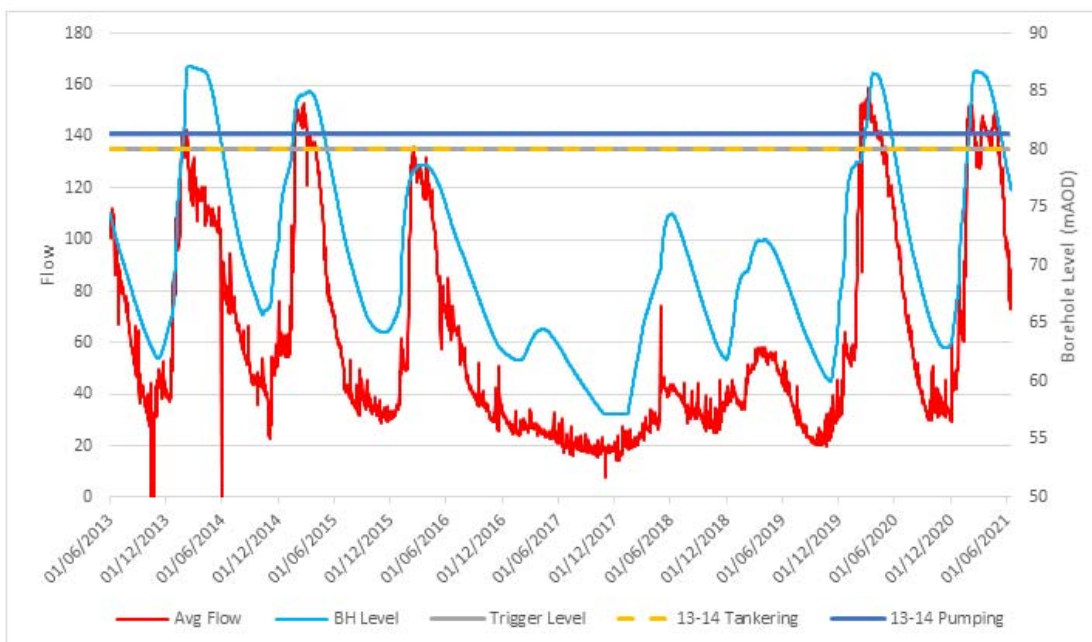
Figure 5.1 – Forecasting of Trigger Dates

The graph below, in Figure 5.1, is an example of those used for predicting the earliest, average, and latest dates for when the trigger levels are forecast to be breached. This graph shows groundwater levels and an indication of flows.

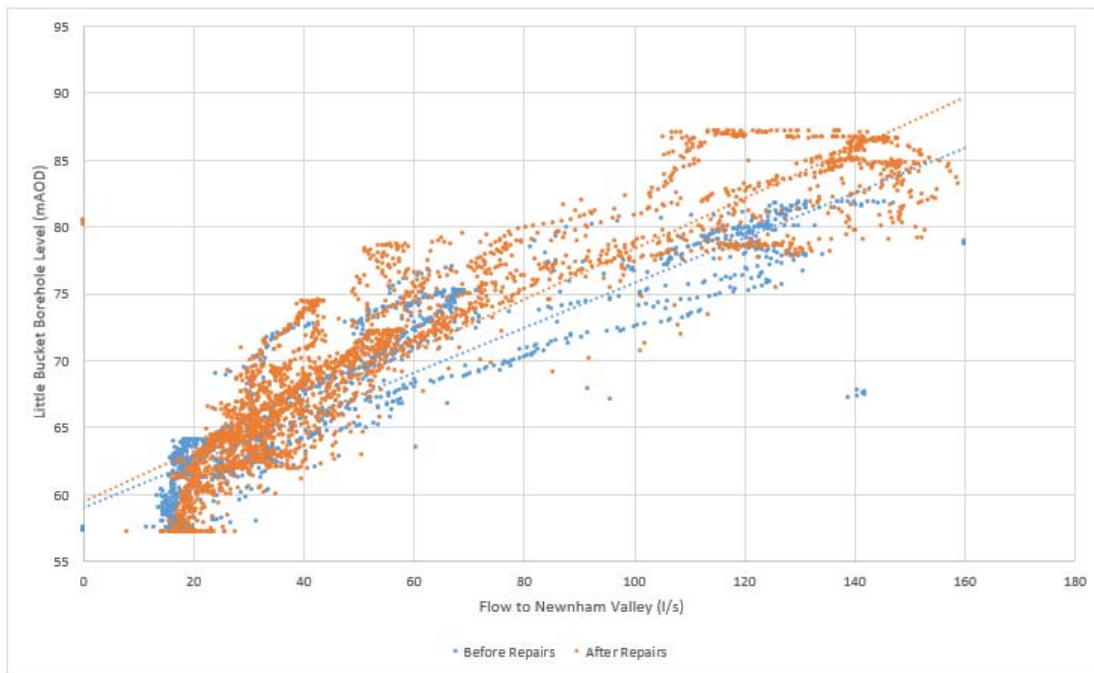
Figure 5.2 – Long Term Monitoring (Dec 2009 to Feb 2021)

Figure 5.2 quantitatively illustrates how flow varies with groundwater levels. It is reasonable that as groundwater levels increase, the rate of infiltration increases. Data points prior to the major repairs are plotted in blue: (Dec 2009 – Aug 2013). The data points for the period after major repairs (Jan 2014 – Jun 2021) are plotted in orange. Linear regression lines are also included for each set of data. These give an indication of the difference between average conditions for 'before' and 'after' repairs.

The difference in groundwater level between the lines is approximately 1.5 - 3m. In other words, for a given groundwater level, the corresponding flow is lower after the repairs. This confirms that the repair work has been effective.

For the period Dec 2009 to Feb 2021, the graph shows that groundwater levels rose higher after the repairs than they had before. This was due to natural variations in the weather. The maximum groundwater level before the repairs was 81.9 mAOD. After the repairs, groundwater levels at Little Bucket reached 87.2m. Despite these higher groundwater levels, flows to Newnham Valley WTW generally did not increase. Indeed, for the period of time after the repair works, the groundwater levels have been higher than 81.9 mAOD for approximately 18% of the time, yet flows have remained in a similar range to that which existed before.
